American Recovery and Reinvestment Act Projects

National Elk Refuge — June 3, 2010

Irrigation Expansion Project

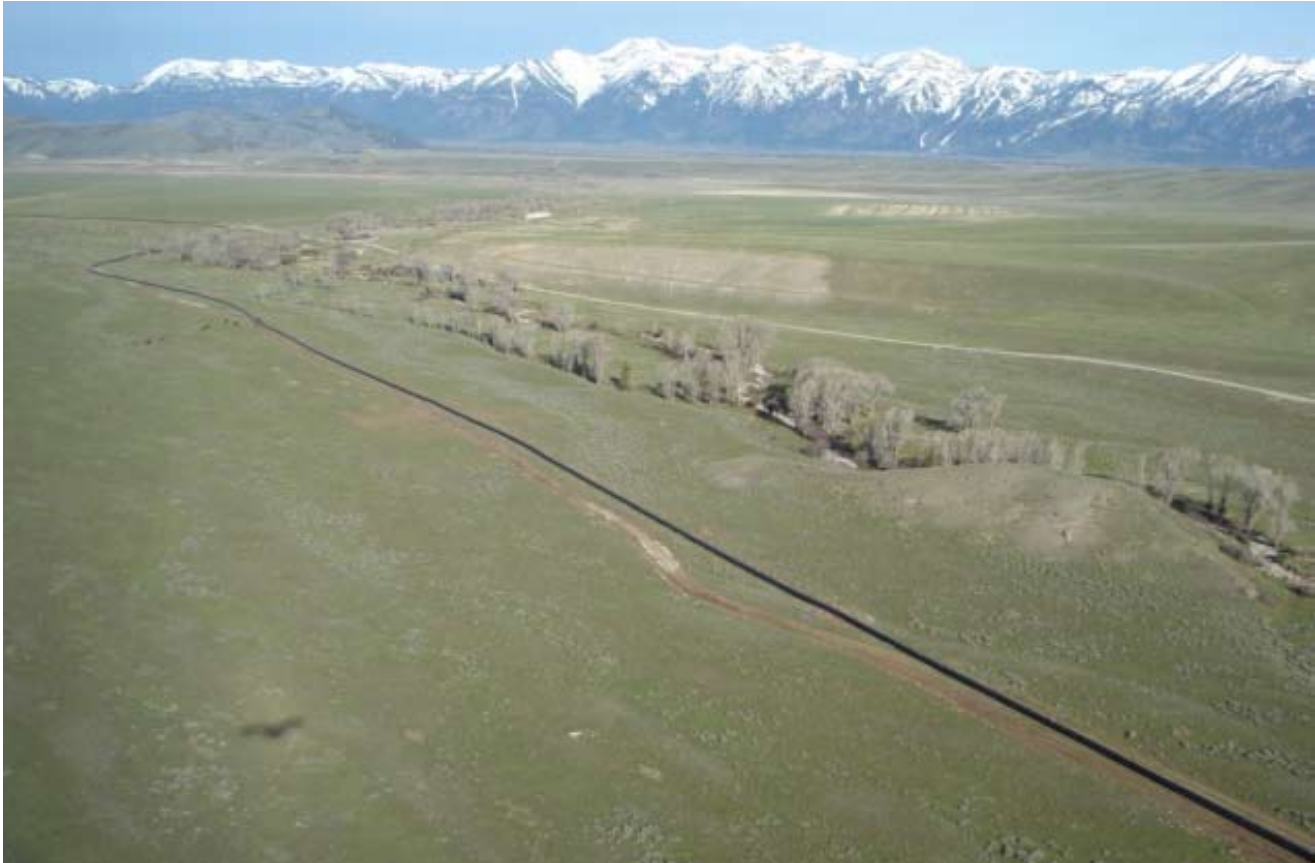
A milestone was reached this week as workers completed fusing the 5.2 miles of main line pipe. Crews began trenching, installing, and backfilling the pipeline at the north end of the project several weeks ago, averaging approximately 600 feet per day as they work through rocky soil.

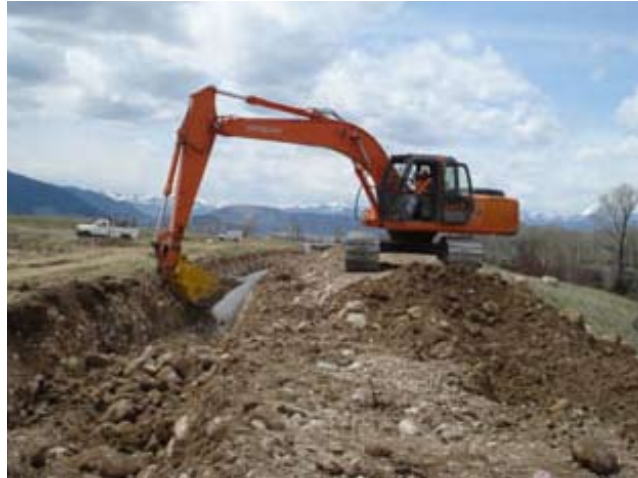
Before the pipeline is backfilled, a screening bucket removes any debris larger than what is outlined in the specifications.

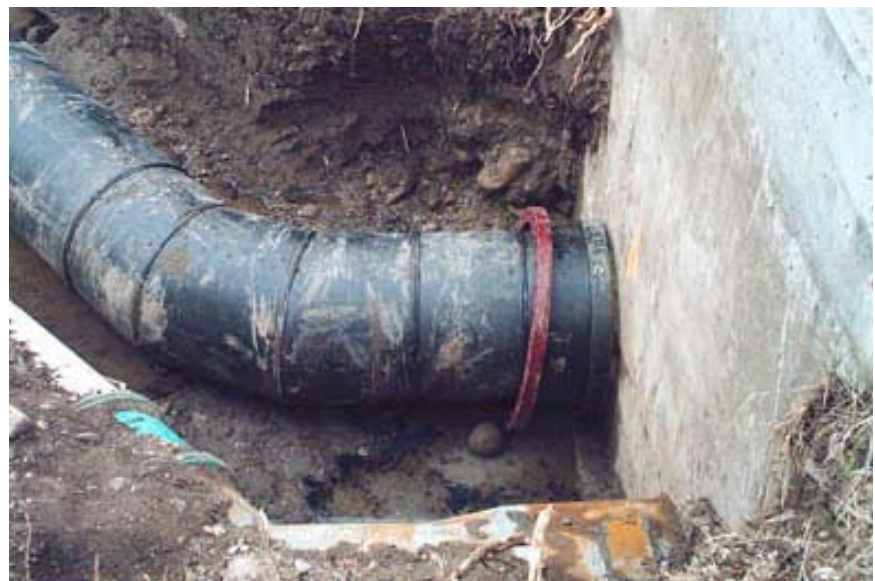
A new section of 24" diameter pipeline (top) is fastened to the concrete headgate next to an existing 27" pipeline (bottom). Water from Flat Creek was temporarily diverted during the operation.

This week, a key project was anchoring pipe to the main head gate on Flat Creek. The head gate, built in 1995, was originally designed to accommodate two pipes. However, only one 1,000-foot section of 27" diameter pipe was

originally installed, with the second never completed or operational. To increase the capacity, crews temporarily diverted water flow away from the head gate to allow them to attach a second 1,000-foot section of pipe to the concrete structure. The two sections of pipe will be joined by a manifold and will feed into the 42" diameter pipe recently installed at the head of the irrigation project.

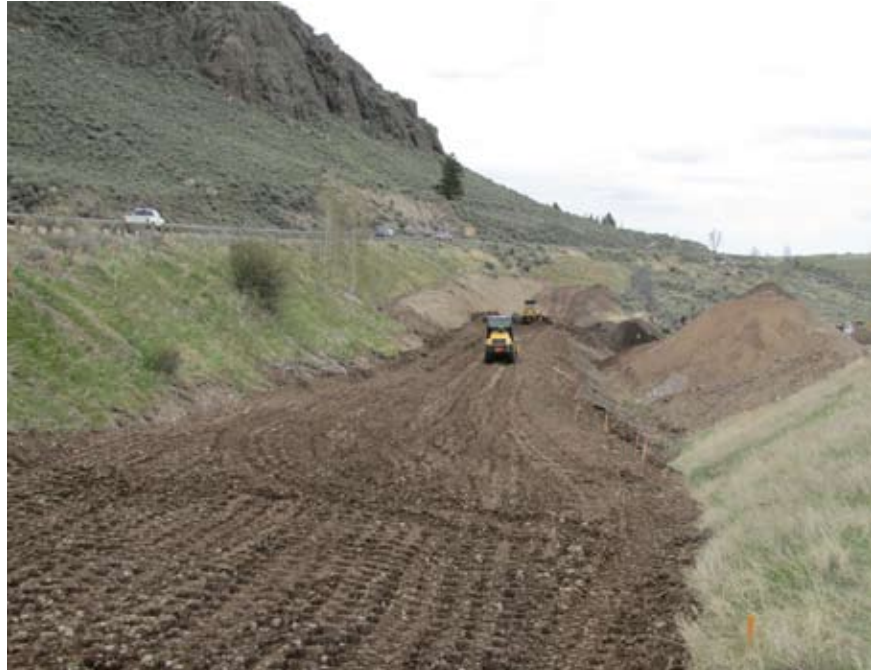
Evans Construction moves a stockpile of fill material onto the pathway route to mitigate a steep grade increase.

While excavation continues on the south end of the pathway near the Flat Creek Bridge in Jackson, crews have been working near the north end of Phase I, or approximately 3.5 miles north of town, to build up a side hill near the Jackson National Fish Hatchery. The design criteria includes a

restriction that pathway grades must be limited to less than a 5% longitudinal slope, making them compliant with American Disabilities Act (ADA) guidelines. Without the side hill work, the pathway would present an approximate 10% grade increase, a steep gain that would not fit within the scope of the project.

Beginning this past winter, Teton County began collecting available fill material from other county and private projects and storing it near the Fish Hatchery's entrance for use in the pathway construction. The reuse of fill material from other projects has resulted in a cost savings of approximately \$75,000.
